3. EXISTING CREEKSIDE ASSESSMENT

The city of Bloomington hired HGA to conduct a needs assessment for a community center in the city. Part of our scope was to review the condition of the existing Creekside Community Center and determine long term maintenance needs, including associated cost estimates.

Bloomington Community Center

Needs Assessment

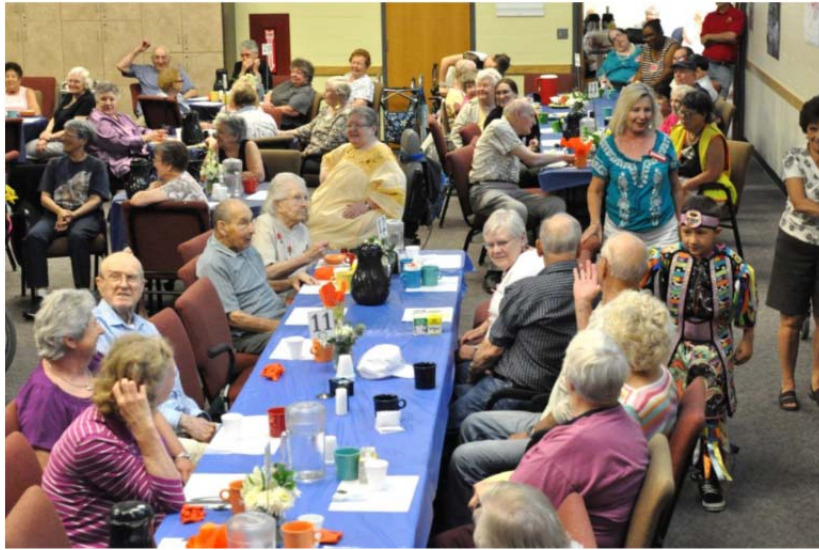
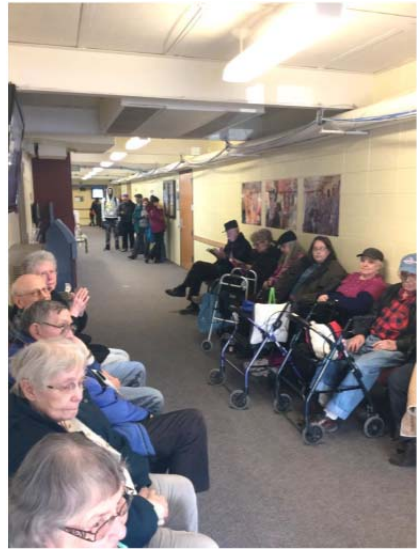
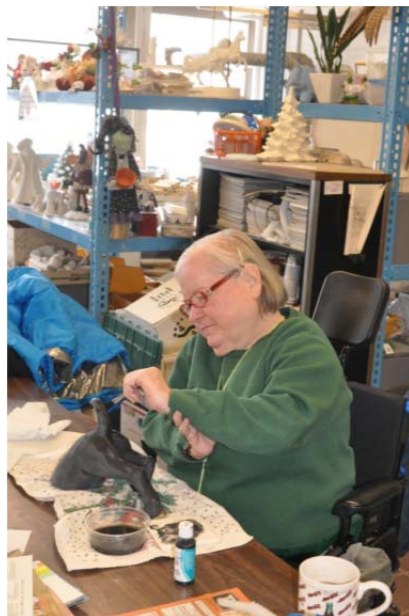
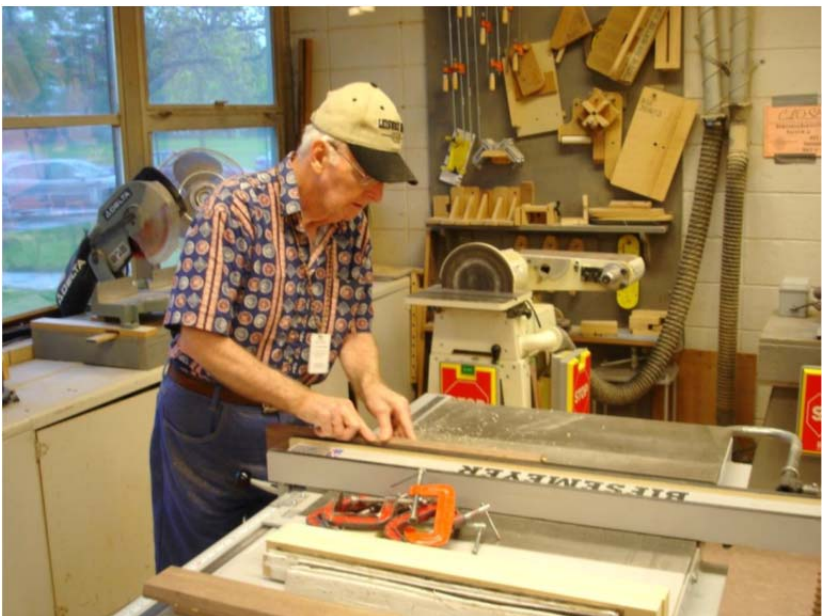
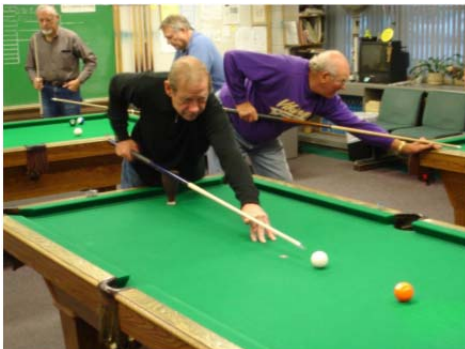
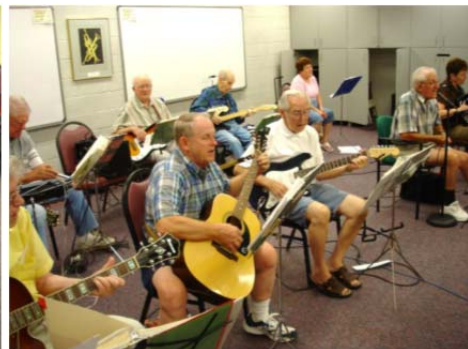
In addition to the building condition assessment, several space deficiencies were documented by staff to illustrate problems delivering current programs. Consistent issues with overcrowding, lack of adequate storage, limited maneuverability, and inappropriate spaces for music and fitness were documented. While the facility is heavily used as a public gathering space, its character, spatial qualities of height and scale and interior finishes do not support this function. The following images illustrate many of the reasons Creekside does not have the capacity to deliver current programs.

Space deficiencies in existing Creekside.

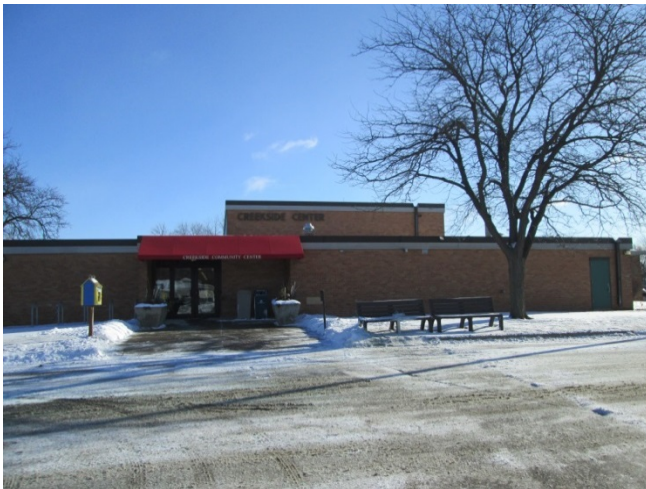
Exterior entrance to Creekside Community Center.

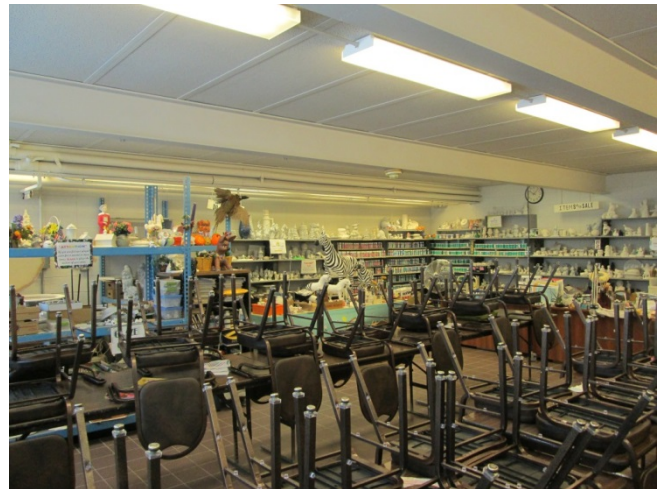
Ceramic classroom.

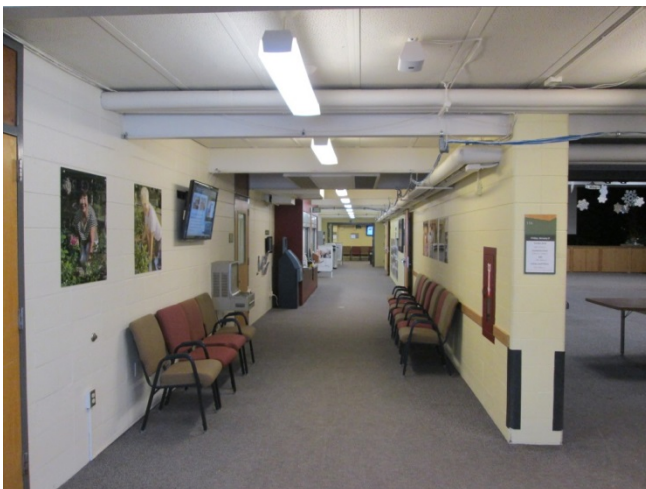
Main corridor showing services below ceiling.

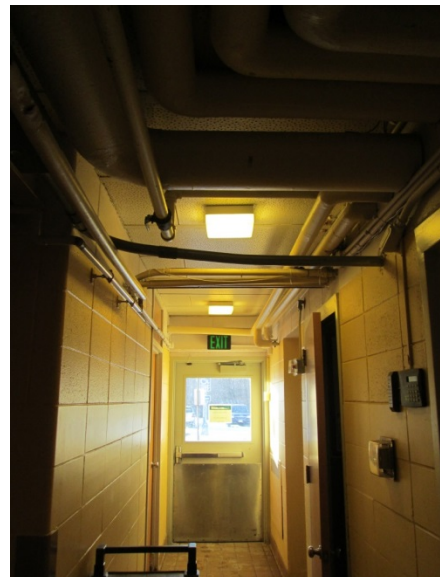
Minor corridor showing service below ceiling.

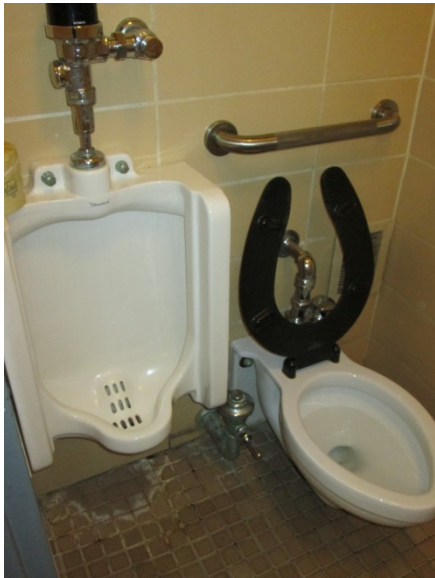
Restrooms are inadequate by current codes. The building is not sprinkled for fire protection.

Existing toilet facilities do not meet current codes.

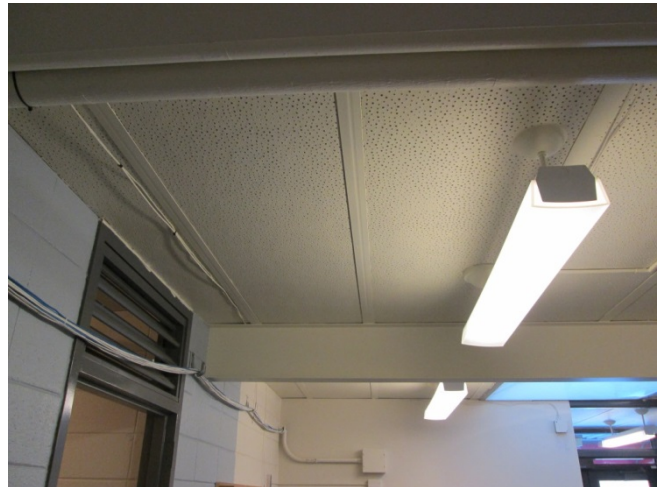
Acoustic form board ceiling is part of original roof deck construction.

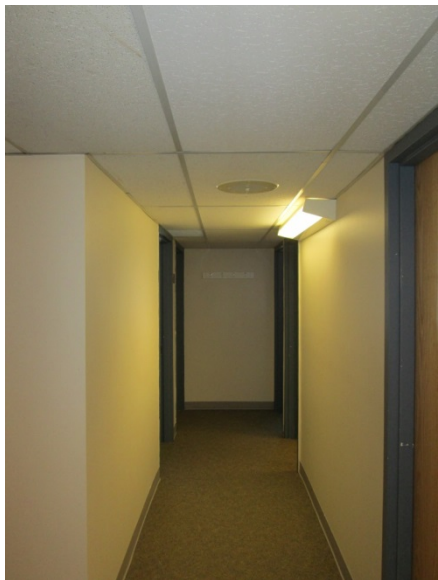
A few areas have lay-in ceilings of acoustic ceiling tile (ACT).

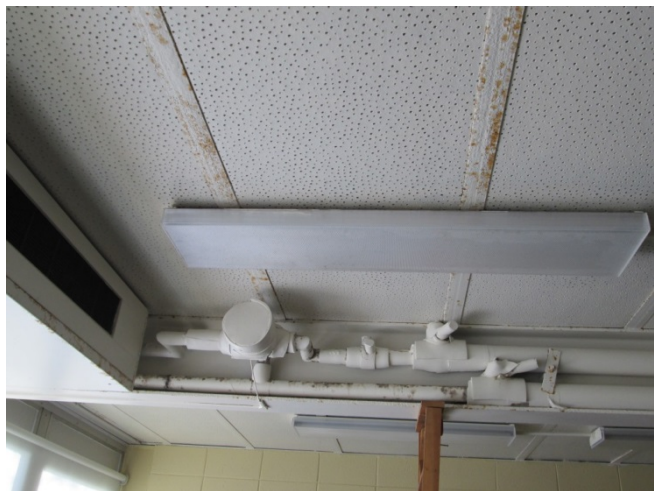
Rust was observed on metal portions of the ceiling system and light fixtures that are in the direct path of supply air from the ceiling mounted cooling units (fan-coils) in a few locations: Buyer's Club room where food is packaged and cooling is used for more hours than in other spaces, and in remodeled offices that have suspended acoustical ceilings, where air conditioning is presumed to be used for more hours of the year. This suggests that the building experiences high humidity in cooling season. The metal components are cooled and moisture condenses on the cold surfaces. When this is repeated consistently for years, the steel surfaces rust (Mech 2, Mech 3).

Black staining was observed on piping insulation that shows signs of compromised vapor barrier, specifically in the vicinity of the rusted ceiling system components.

Evidence of moisture problems is visible.

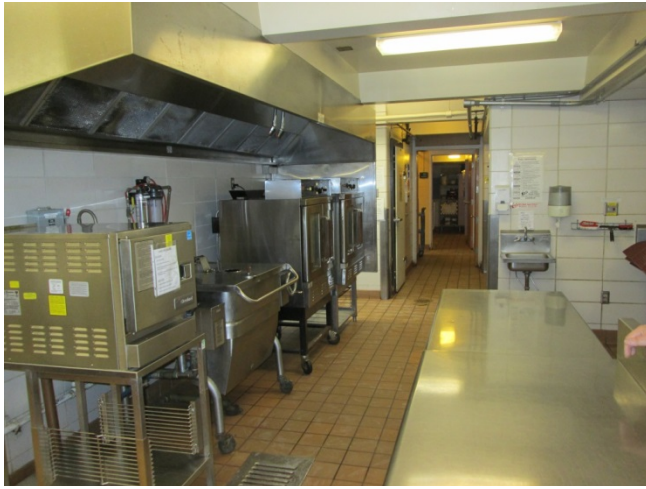
Some floors appear to be in very good condition.

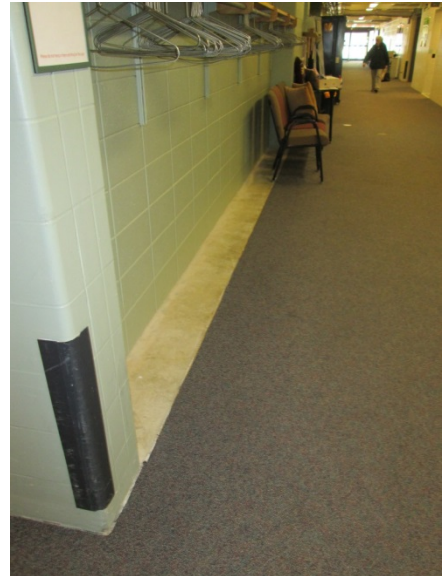
Some floors appear to be in very good condition.

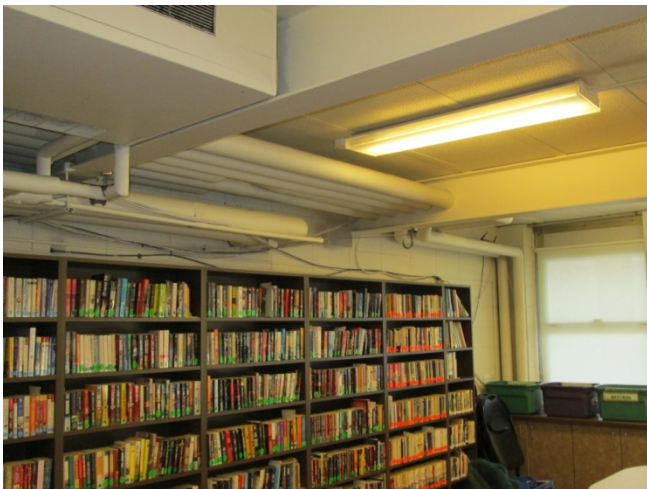
One of the more challenging obstacles to upgrading the spaces and systems of the Creekside Community Center facility is the inflexibility of the structural system as it is integrated into the building's architecture. Because the "finished" underside of the roof deck and its supporting beams are exposed (8'-8" to the bottom of the deck, 7'-8" to the bottom of the steel beams), all horizontal mechanical and electrical systems are also exposed, and those which cross the beams must either penetrate the beams or drop to 7'-4" or lower. In order to conceal any portion of these systems, a ceiling would have to be installed at an unacceptable 7'-0" or lower above the finished floor. Given this aspect of the building's architecture, designing and installing comprehensive renovations of or substantial additions to mechanical, plumbing, electrical and lighting systems would be difficult at best, unless portions of the roof were raised or added onto, and/or unless building additions were placed along one or more sides of the building perimeter.

Low ceilings and exposed mechanical and electrical systems contribute to inflexibility of spaces.

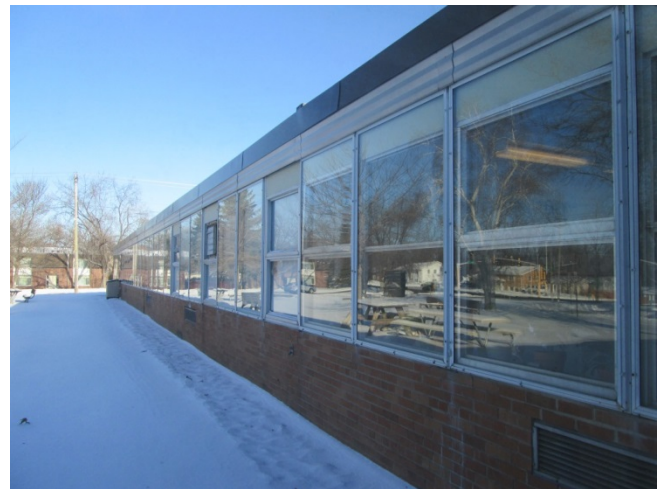
up of the original aluminum-framed, single-glazed windows that provide wonderful daylight but also considerable heat loss to each room. Nearly all have been covered with glazed storm panels, improving their performance, but still not reaching the level of today's insulated and/or translucent glazing options. Original construction drawings do not show any insulation in the exterior masonry walls, though more recent notes on existing drawings indicate that some masonry cores may have been filled with vermiculite. There is a noticeable temperature difference between the inside surface of exterior masonry walls and that of interior masonry walls, even in the same room. Though the exterior face brick itself is in relatively good condition, the mortar joints should all be repaired and repointed as necessary, especially at building corners and cabinet unit heater air intake louvers. Control joints may need to be added where mortar joints have severely cracked and separated.

Glazed storm panels cover most original single glazed windows.

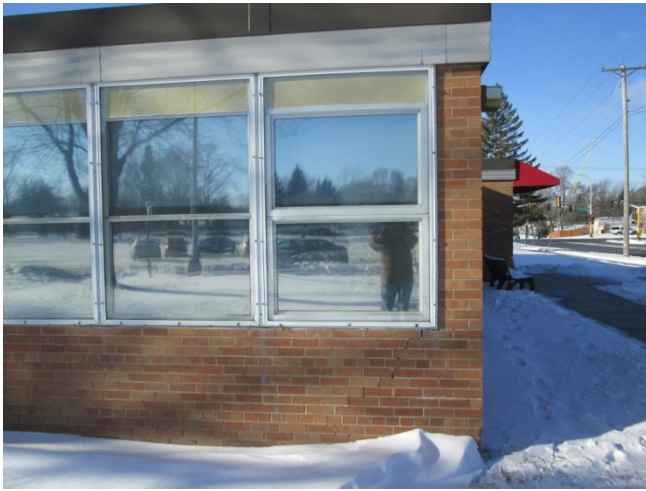
Repair and repointing mortar joints is recommended.

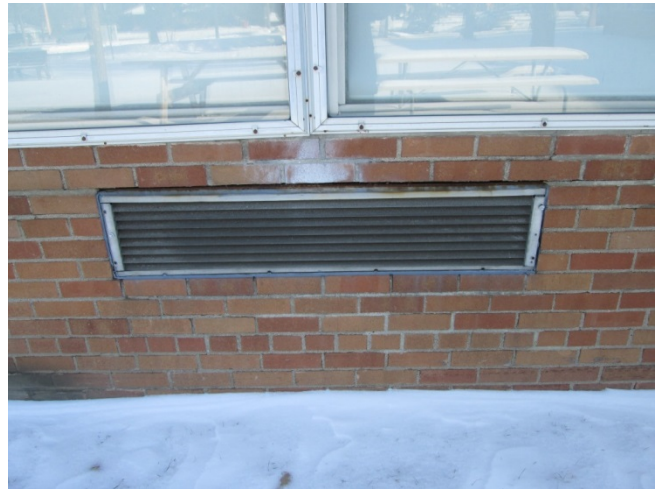
Original unit ventilator.

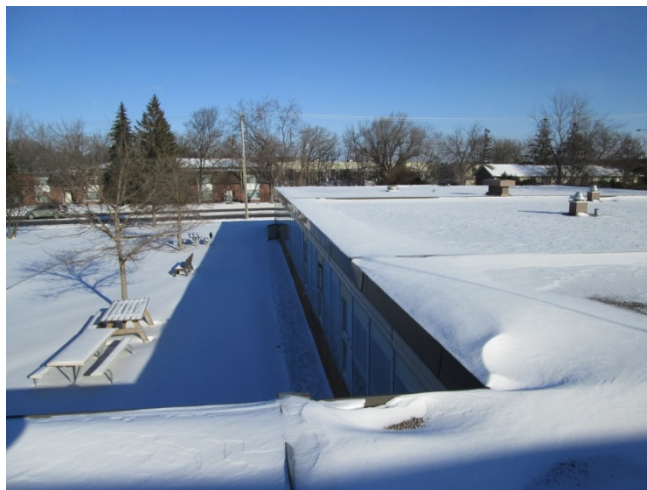
The two-level roof had its built-up roofing (BUR) membrane replaced in 1981, and portions have been patched and/or replaced at various times since. Leaking is evident in several locations and annually requires immediate temporary solutions, typically after the spring thaw cycle. The roof contains much less insulation than is required to meet today's Minnesota Energy Code, and to meet the minimum roof slope requirements of the Minnesota Building Code. This could be remedied during ongoing or future roofing replacements by adding more and better tapered insulation, but would probably require raising the building roof edge height and possibly adding more roof drains. Additional overflow scuppers would also need to be added where required.

Photographs of the roof in summer indicate that some portions of the roof are ponding water and not draining properly. The roof slope seems very flat and roof scuppers quite distant from the roof drains. The drainage should be repaired and brought up to code to prevent overloading of the roof structure due to ponding of water.

Better insulation and tapering is recommended with roof replacement.

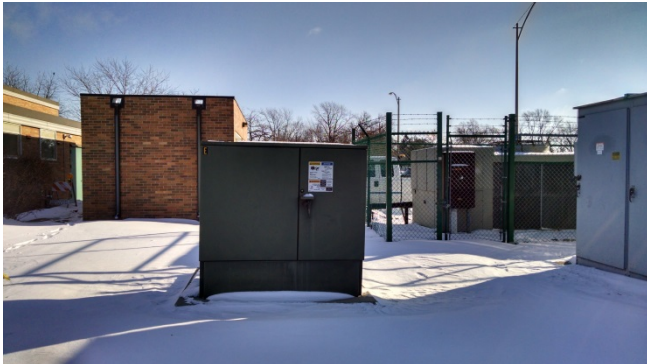
Xcel pad mounted transformer (225 kVA) outside the east wall of the building.

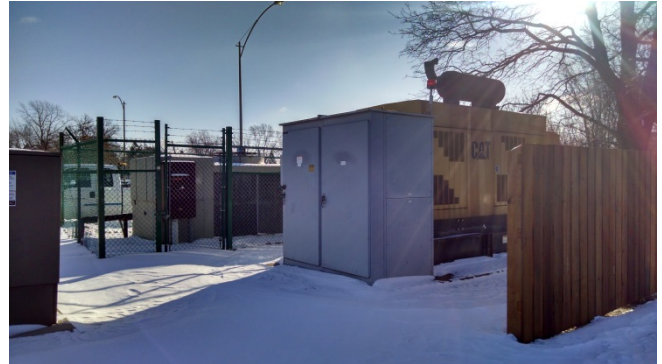
Transfer switch mounted at the emergency generator.

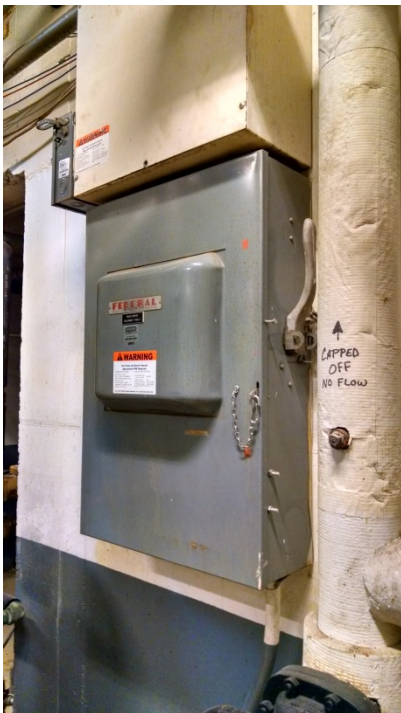
Main disconnect switch in the boiler room.

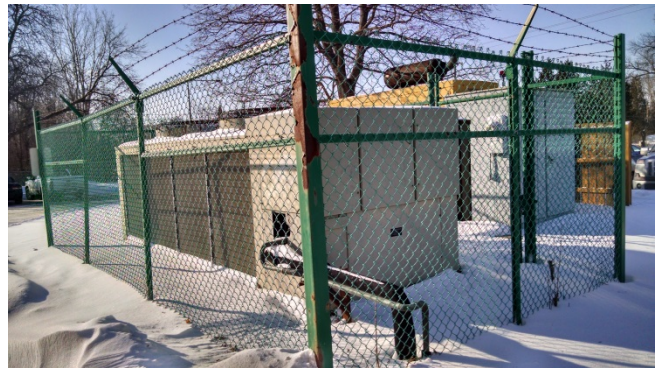
The chiller is tapped off the Xcel service and is not backed up by the generator.

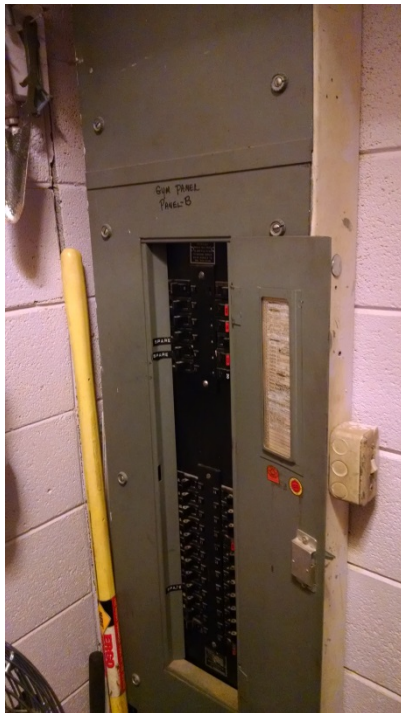
Electrical service equipment is in good condition; however, it is original FPE brand equipment. FPE circuit breakers are known for not tripping (opening) under short circuits and are therefore unsafe. Panel replacement should be included as a maintenance item. The feeder distribution panel is located in a storeroom across from the kitchen. From this location, panels near the gym, each classroom wing, boiler room and kitchen provide power for lighting and receptacle circuits. This storeroom area also has very low structure, which would hinder adding feeders to the existing distribution panel. The equipment in each location has adequate clearance to the front and working space from side to side.

Original FPE brand electrical service equipment.

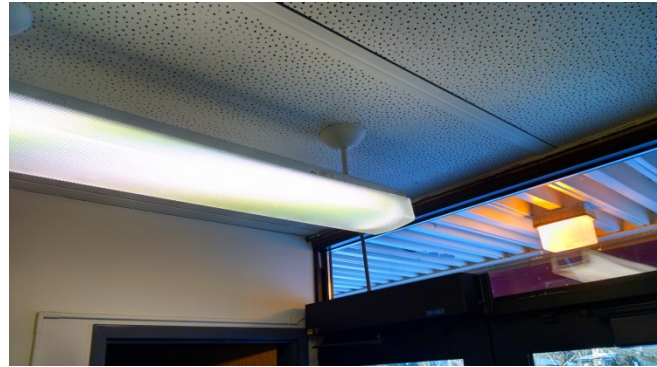
Interior lighting is a mix of fluorescent and incandescent, with exterior and site being mostly high-pressure sodium. The interior fluorescent lighting has been mostly retrofitted to T-8 lamps and electronic ballasts. There are some locations with T-12 lamps remaining. There is limited battery pack egress lighting and battery pack exit signs. LED site and exterior lighting should be considered for energy savings and reduced maintenance.

Interior lighting is a mix of fluorescent and incandescent.

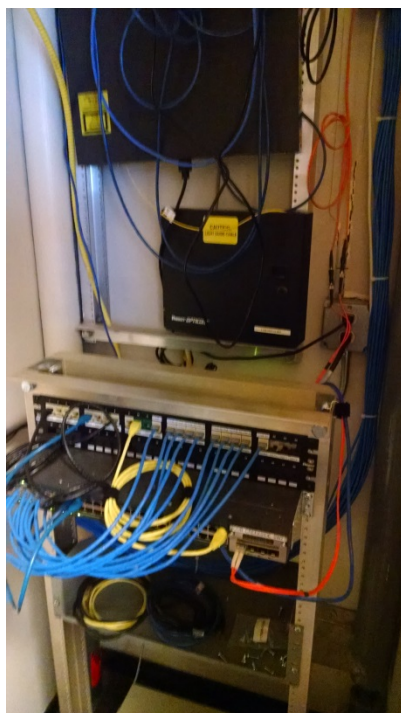
The building has a fiber optic service for phone and data connections. Fiber entrance is in the lower level boiler room near the electric service equipment. On the main floor level there is a small storage room with IT equipment on wall-mounted racks in the office area. Typical practice is to have a telecom closet for IT equipment and cabling to terminate in that has a separate cooling system to provide 24/7 system cooling.

Wall mounted IT equipment without separate cooling system.

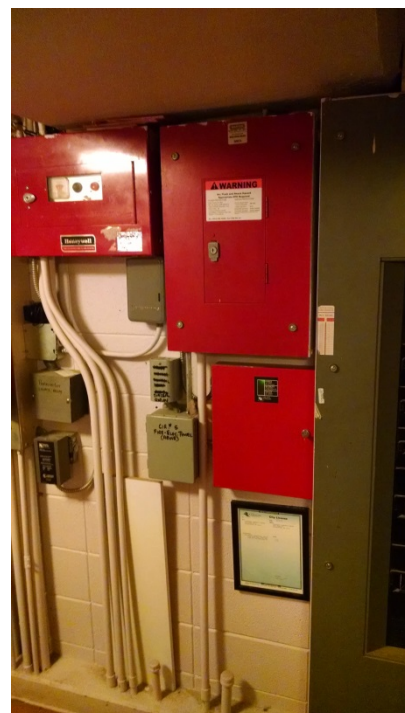
There is a minimal fire alarm system in the building with limited automatic, notification and manual system. The existing Honeywell system is not code compliant. The existing system is a line voltage (120-volt) system and parts are no longer manufactured. The building is not sprinklered. The fire alarm system should be replaced with modern equipment and in compliance with current codes.

Existing Honeywell fire alarm system is not code compliant.
