# APPENDIX A: HABITAT ASSESSMENT

## Appendix A: Habitat Assessment

In May and June of 2017, Great River Greening (GRG) conducted a habitat assessment in ten (10) delineated management areas (figure 4.3) of the River Valley. Some of the management areas are further divided by uplands and lowlands or east and west to account for differing management strategies. The nineteen (19) subareas are further identified by land cover type with a corresponding number and letter that were assigned with a survey conducted for Hennepin County's 2007 Natural Resource Inventory (NRI). Ecological community descriptions are provided for each of the subareas as defined in the Minnesota Land Cover Classification System.

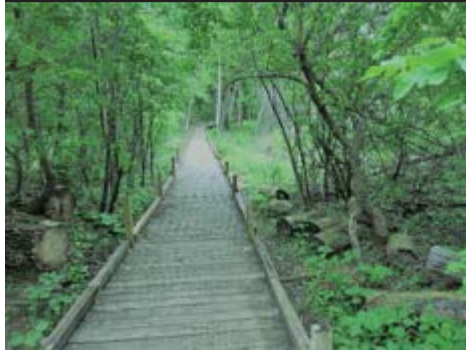
Photo 1: Standing in 29E - 29I looking towards 29D at the far end of the boardwalk.

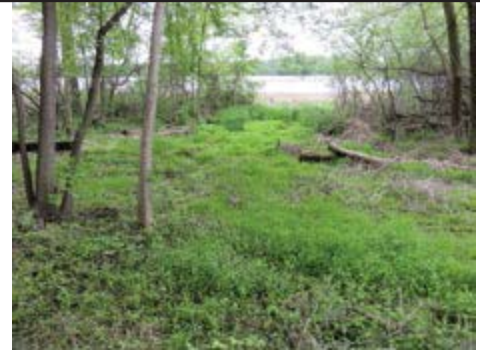
Photo 3: Opening with sunlight permits continuous vegetation, mainly beggars tick, prairie sedge, rice cut grass, and Michigan lily.

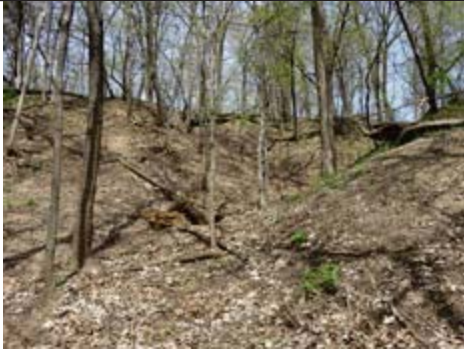
Bare soils above 29F

Although the 2007 inventory lists this area as a lowland forest, this report proposes a reclassification of 29F as part of the uplands due to the excessively drained and typical upland soil type found here. The largest trees are sugar maple, red oak and basswood with some displaying greater than 32" dbh. The forest vegetation along the spring stream includes sugar maple, wild leek, Dutchman's breeches, nodding trillium, early meadow rue, Virginia waterleaf, snow trillium, rue anemone, wood anemone, yellow trout lily, and hepatica. Despite the unique forest vegetation, the overall ground cover is sparse.

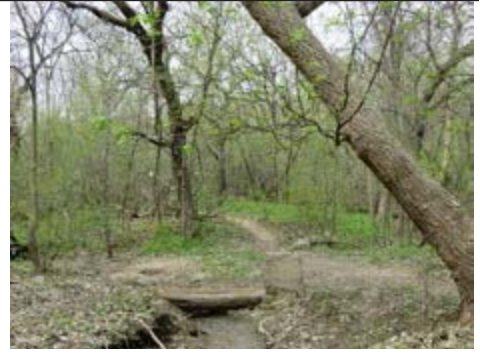
Looking upstream from 39B

Further downstream at the transition of 29F and 39B, the vegetation changes according to topography and hydrology. Cottonwood trees and silver maples replace the sugar maple and oak from uphill. Open growth cottonwood and oak occur along a sandy plain where a bridge once crossed the stream. The older trees are subsumed by dense, young, woody vegetation such as boxelder, hackberry, green ash, red elm, and cottonwood. There are a few prairie crabapple and American plum trees, which cling to small gaps in the canopy along the stream and trails. The main shrub layer is buckthorn, at times so dense as to make walking difficult. The rich soils facilitate the domination of shade tolerant, nitrophilic species such as garlic mustard and wood nettle. There is also excessive dead, fallen wood.

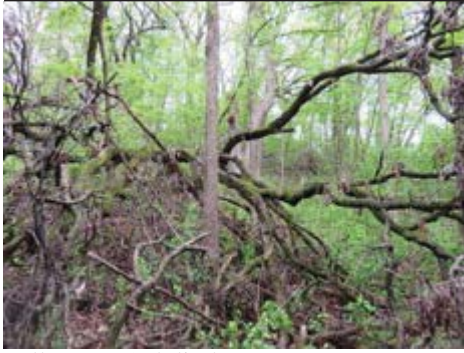
Fallen Bur Oak limb

Large, open growth bur oak and red oak show symptoms of stress due to competition for sunlight and high humidity. There is no evident oak regeneration. Some oaks have died and fallen, contributing to the large amounts of dead, fallen wood in the area.

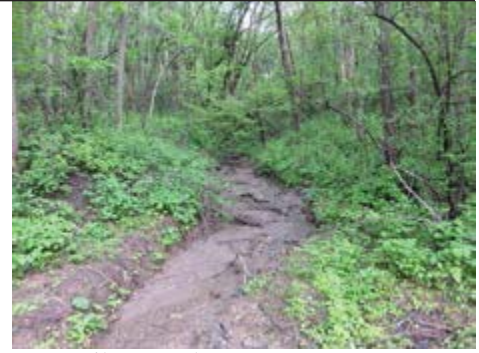
Bare soils around stream

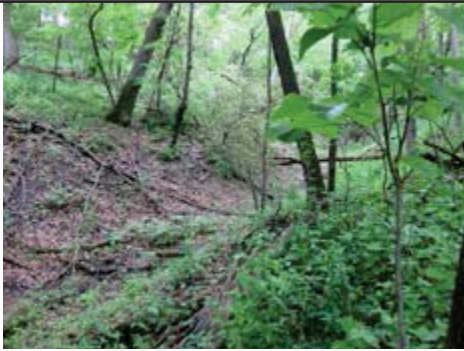
Seep stream flowing from private residential property

The 2006 survey indicates a much higher diversity for the wetland area, and many of the species are absent in 2017. Potential causes of this include dense stands of buckthorn that are now taller and creating more shade, the emergence of garlic mustard, and increased shade from all species of trees. The community is dominated by silver maple, black ash, and small red elm, hackberry, and green ash. The ground layer is dominated by wood nettles and garlic mustard. Impatiens and clear weed are ubiquitous throughout. Quality vegetation occurs in the southwest section of 39H adjacent to the lakeshore because it escapes the high levels of nutrients and weedy species associated with the seep stream.

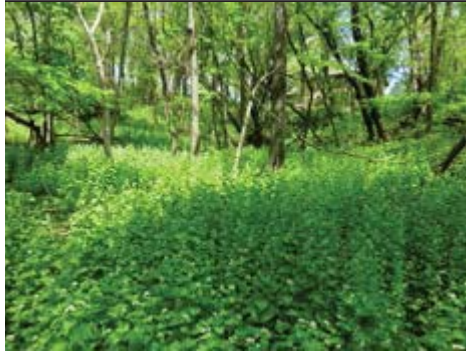
Dense stands of garlic mustard

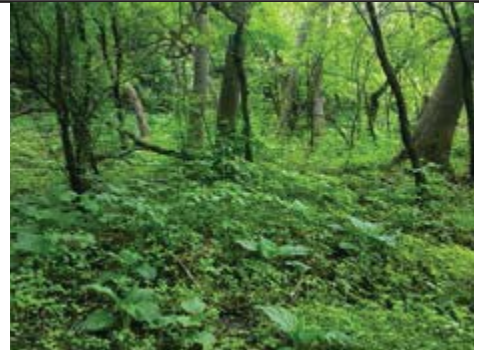
Seeps at the bluffland base

The dominant woody vegetation in the seeps is black ash, pussy willow, and Bebb's willow. Black ash trees are scattered, and are not the primary factor of shade. Bebb's willows, pussy willows, buckthorn, red elm and hackberry provide the greatest amount of shade. Glossy buckthorn is becoming more evident. Ubiquitous plants include smartweed, beggar's ticks, and impatiens. Unique plants include marsh marigold, spring cress, tufted loosestrife and skunk cabbage. Several indicator species, such as Michigan lily, tussock sedge, and sensitive fern, were recorded in 2006 but were not found in the 2017 inventory,

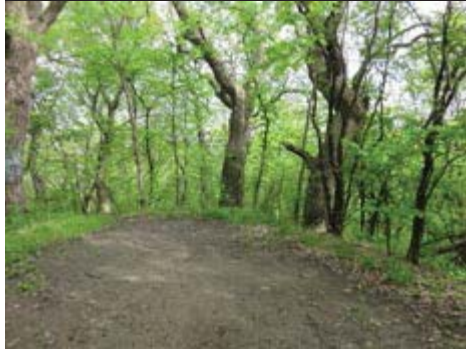
Open growth bur oak at the Parker's Picnic Grounds trailhead could be 250-500 years old.

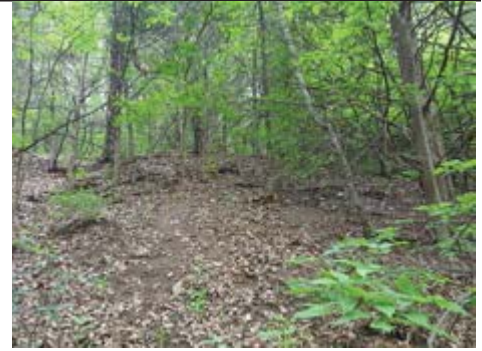
Bare soils along the Bluff trail.

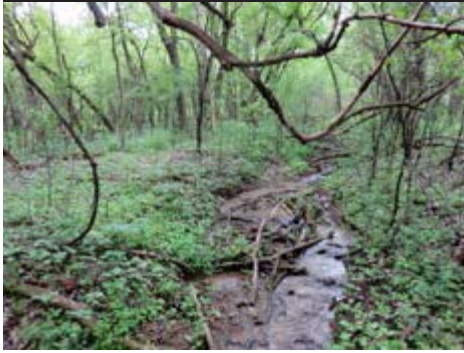
Stream flowing through delta over cobblestone. Lack of grass cover allows the stream to spread out, without a realized channel.

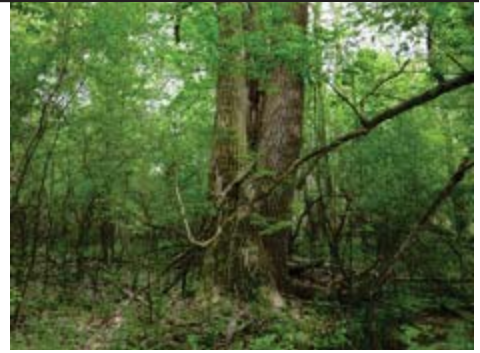
Open growth cottonwood on the cobblestones of an ancient river shoreland is surrounded by weedy trees, all competing for sunlight.

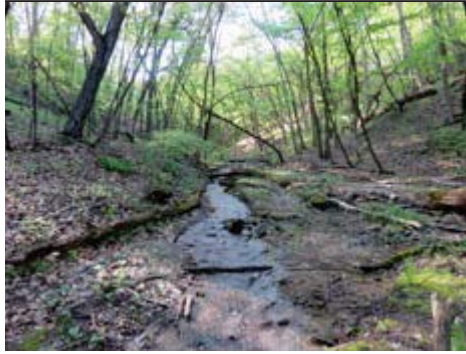
Photo 65: The west aspect of the stream, once a shortgrass-savanna, is on the right. The east aspect, historically an oak basswood grove with forest vegetation, is on the left.

The east facing slope along the ravine has good ground vegetation cover. This is one of the healthiest landscapes in the Minnesota River Valley. However, the west facing aspect is bare of ground vegetation. On the terrace above the stream fork, there is one of few large white oak trees (32" dbh) found in the valley. It sits in the center of a Native American encampment site.

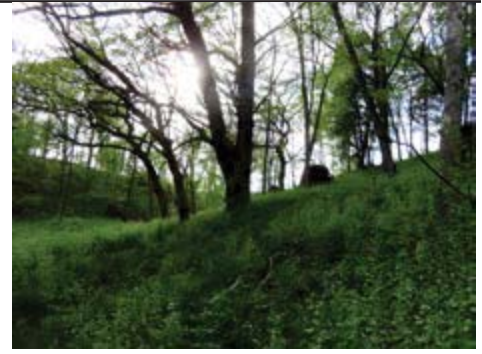
Photo 68: The restored site in 39B. One of the goals at this site is to achieve Bur oak regeneration.

The restored portions in 38B have improved drastically compared to what they looked like before restoration. However, the site will quickly revert back to a forested state if sunlight fails to reach grasses and flowers through the trees. Other concerns include the high nutrient levels associated with soils on the site and the stacked wood piles that decompose and add nitrogen to the soils.

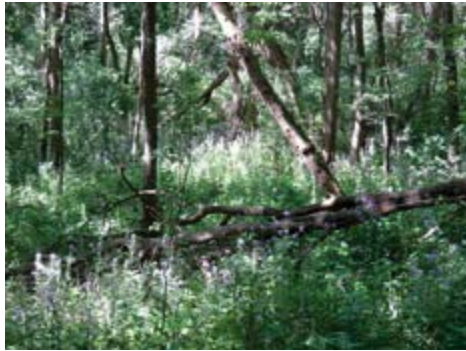
Lower elevations in 38F contain richer soils and weedier growth

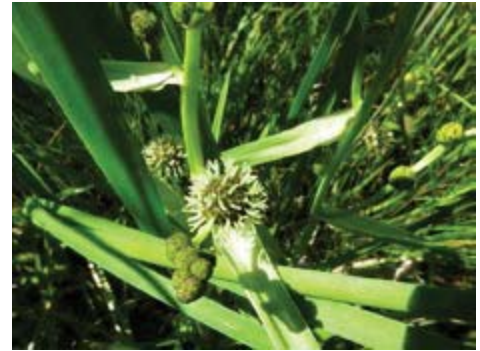
Giant Bur Reed found along mowed right-of-way

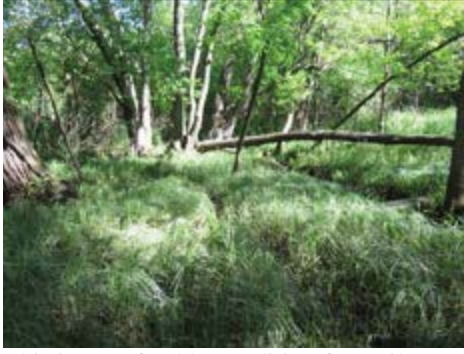
This is a preferable condition for a silver maple/cottonwood grove, with enough sunlight to allow continuous ground cover.

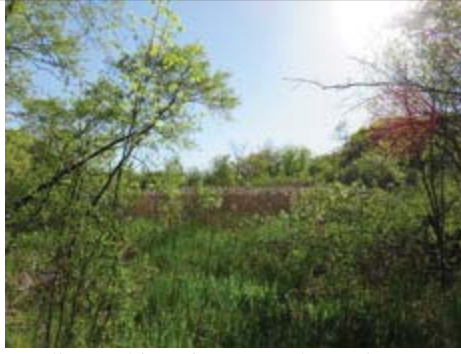
Quality rankings in 38L and 38N have been downgraded partly due to continued woody encroachment.

Prescribed burns are needed to fend off woody species and remove nitrogen. However, burning may not be feasible for such a large area in an urban setting. Mowing will set back woody species, but doesn't regulate nitrogen inputs from plant debris. However, mowing will protect against woody encroachment, reduce nutrients, and create a biomass feed stock for energy production. The most efficient method for controlling woody encroachment is by promoting beaver populations.

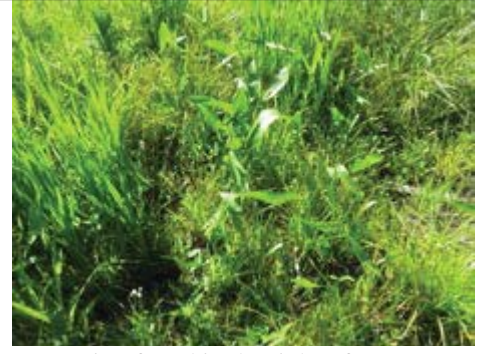
Vegetation found in the right-of-way includes porcupine sedge, giant bur reed, arrowhead, marsh skullcap, and cottonwood

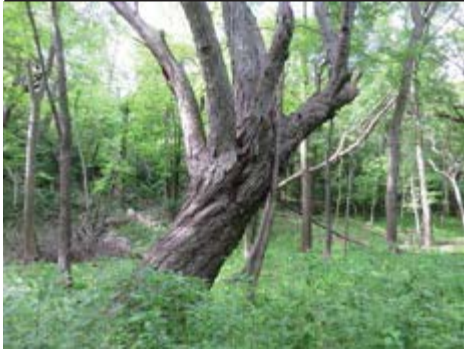
The dominate vegetation is cottonwood and silver maple, which are represented by three age classes. The first age class consists of a few open growth form trees (50"+ dbh).

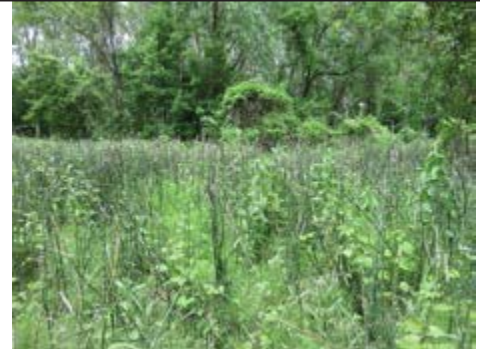
A sunny patch, dominated by scouring rush, horse tail, Canada thistle, burning nettles and riverbank grape.

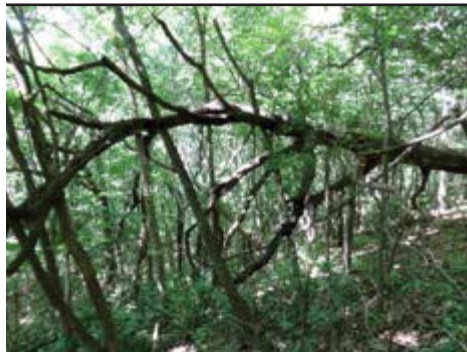
Photo 83: A variety of pole trunk, low quality tree species dominate system dynamics. Note the death of an open growth oak and the absence of a ground layer of vegetation in the background.

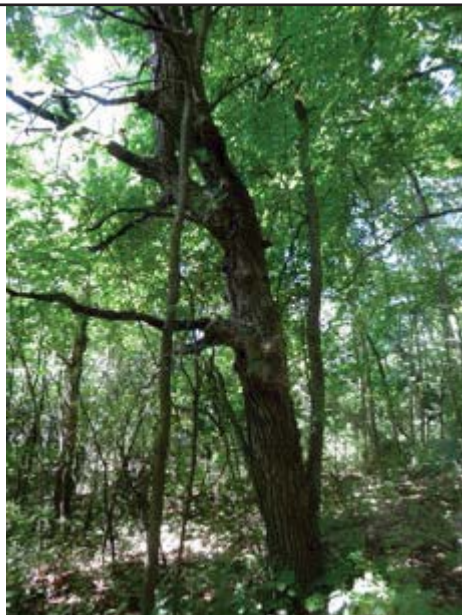
Photo 84: Bur oak with multiple stumps indicating sunlight competition, and sloughed lower limbs.

The once diverse, open landscape has been replaced with occluded, overgrown vegetation. Open growth bur oak (22 – 24” dbh) and red oak (24” dbh) are stressed due to sunlight competition from hackberry, red elm and green ash. Hackberry is particularly aggressive in this area. In the higher elevations, the shaded, well-drained soils are

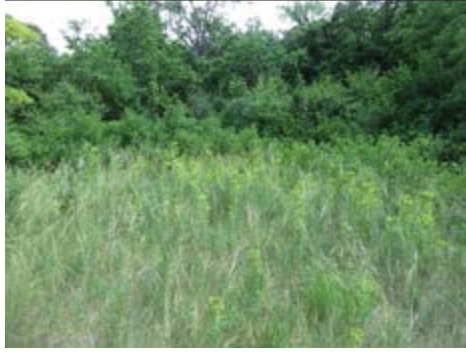
Deer have controlled sumac and Siberian elm in 46B, which was noted as a problem in the 2007 survey. There are unique species associated with this unit, but fully restoring this site will require prescribed burns, biomass harvest, and introductions of outside genetic pools.

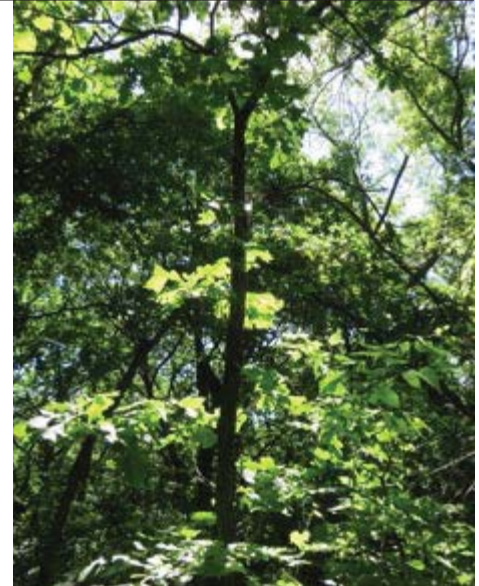
The youngest bur oak found during the 2017 survey. This tree likely grew in a recently afforested prairie knoll. In this shade, the tree will not survive. As elsewhere in the valley, bur oaks are not regenerating.

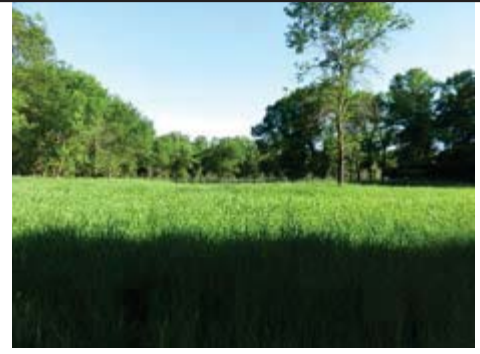
Reed canary grass, phragmites, and cattails are among the undesirable species that dominate area dynamics.

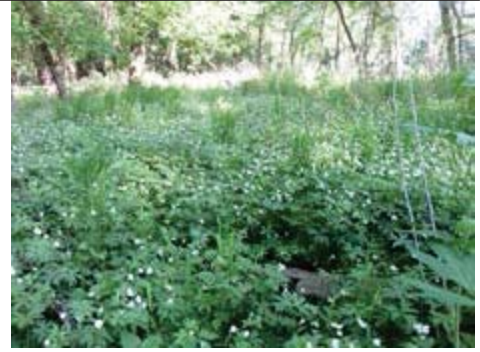
A potential restoration target is Mesic Savanna, where enough sunlight allows for higher quality grassland species to coexist with pools of shade.

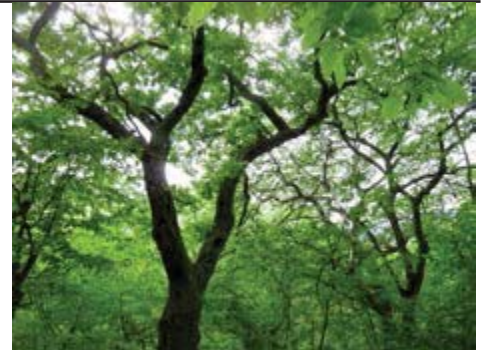
Open growth bur oak is stressed by native trees growing up through their limbs, and competing for sunlight.
