UTILITIES ANNUAL REPORT

FOR BLOOMINGTON, MINNESOTA • 2015 YEAR END

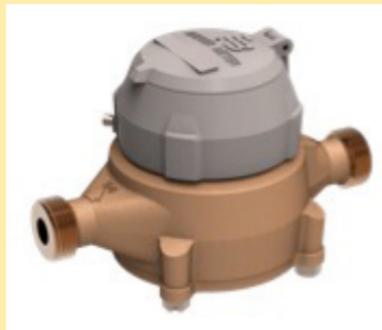
The Utilities Division is actively exchanging the remaining pulse-generating water meters in the water system with encoder meters. The existing meters utilize an electrical pulse that captures the reading based on each unit of measured water. The electrical pulse is transmitted over a two-conductor cable to the remote readout module.

The replacement encoder meters utilize a technology that provides the ability to easily, quickly and accurately collect meter reads. The register on the meter converts the reading into a digital data format that can be collected without manual data entry.

The meters can be fitted with a radio or a touch pad to help facilitate the reading collection process. With touch-based reading, a meter reader carries a handheld computer or data collection device equipped with a wand or probe. The device

automatically collects the readings from the meter by touching or placing the read probe in close proximity to a reading coil enclosed in the touchpad. The probe sends an interrogate signal to the touch module to collect the meter reading.

The software in the device matches the serial number to one in the route database, and saves the meter reading for later download and utilization with the billing system. The radio reading process utilizes a similar process except the interrogate signal and returned meter reading are transmitted on a Federal Communications Commission (FCC) licensed frequency.
