# UTILITIES ANNUAL REPORT

FOR BLOOMINGTON, MINNESOTA 2020 YEAR END

## A YEAR LIKE NO OTHER

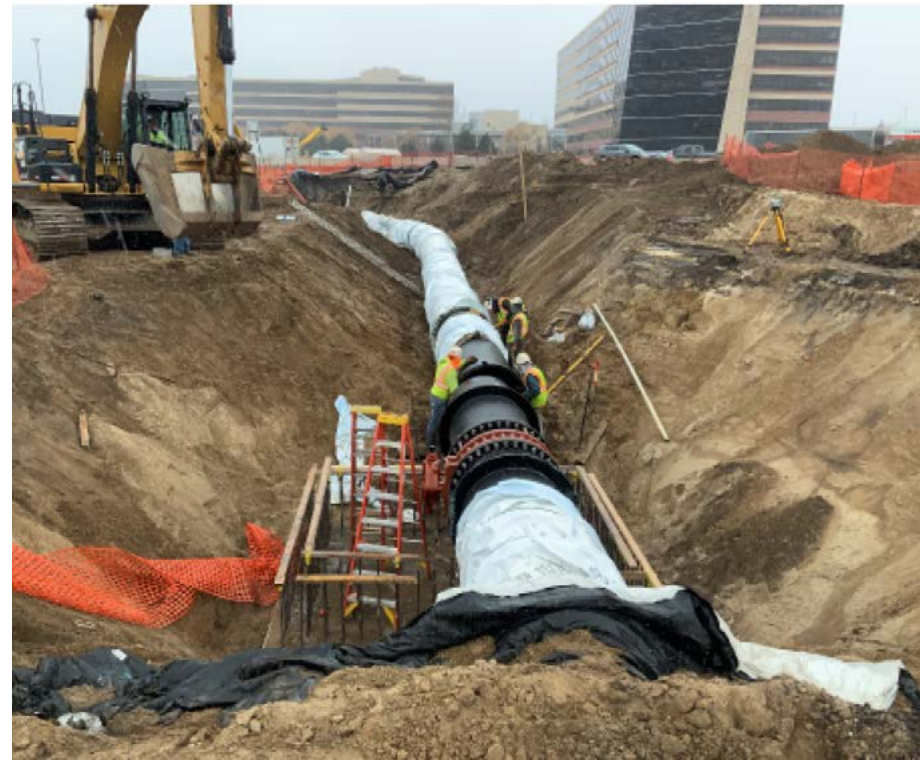
Construction crew installing the new 42" looking north from the south side of 494.

The 42" watermain is made of ductile iron and a poly wrap is installed over the pipe to protect it from future corrosion. Each piece of pipe was specifically made to length and assigned a number to be installed in a designated order. A portion of the 42" line that crosses under the highway is installed in a steel casing which is placed first, then the pipe is pushed into the casing.

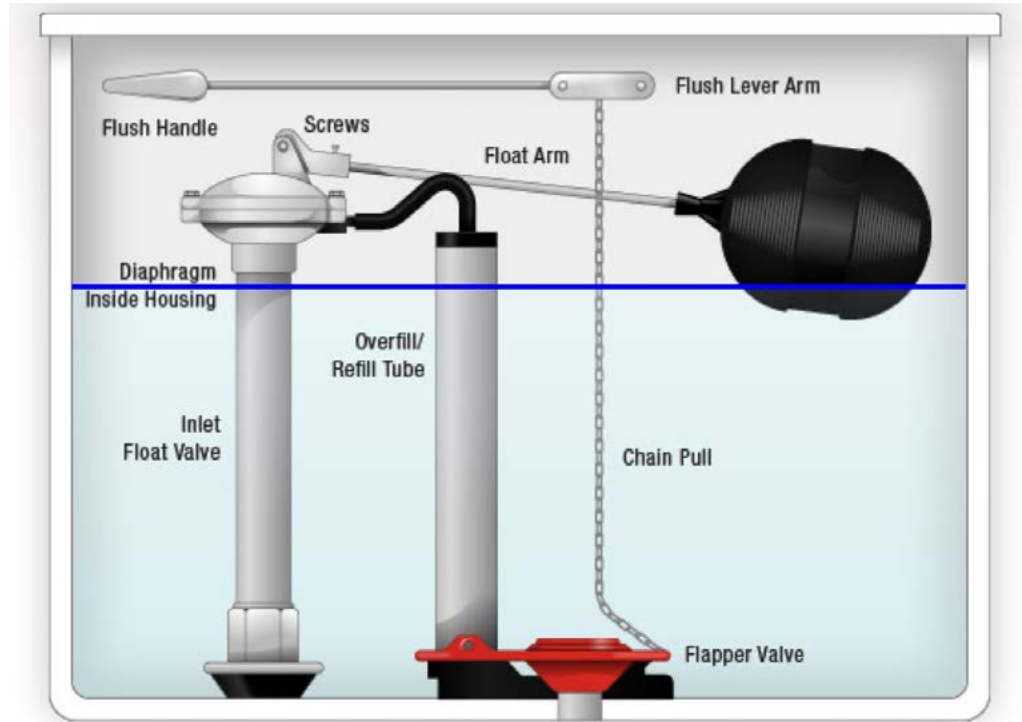
It's not always easy to tell if your toilet is leaking. Toilets can either leak at the flapper valve or waste water through the overflow/refill tube. To check for a slow leak, remove the toilet tank lid, and drop in a dye tablet or a couple drops of food coloring in the tank, and wait 10-15 minutes. When you return, look in the toilet tank bowl, and if you see colored water, you then know you have a leaking flapper valve. You will then want to replace the flapper valve.

- **STEP 1:** Start by removing the toilet tank lid and check the float arm. Reach in and lift it up. If the water stops running, you have found the issue. If not, adjust the screws or bolts to the inlet float until the water stops running.

- **STEP 2:** If the toilet is still leaking, you may have a problem with the fill valve. If this is the case, a steady trickle of water will continuously run, flowing into the overflow tube in the toilet tank itself. If this is the case; unless you look at the water level in the tank, this type of leak will go undetected until you receive your water bill. Try and adjust the float level so that the water stops filling before it reaches the overflow level. After adjusting, flush the toilet a couple times to ensure that everything is working properly and that the water level in the tank is slightly below the top of the overflow tube line.
