# APPENDIX A: HABITAT ASSESSMENT

## Appendix A: Habitat Assessment

In May and June of 2017, Great River Greening (GRG) conducted a habitat assessment in ten (10) delineated management areas (figure 4.3) of the River Valley. Some of the management areas are further divided by uplands and lowlands or east and west to account for differing management strategies. The nineteen (19) subareas are further identified by land cover type with a corresponding number and letter that were assigned with a survey conducted for Hennepin County's 2007 Natural Resource Inventory (NRI). Ecological community descriptions are provided for each of the subareas as defined in the Minnesota Land Cover Classification System.

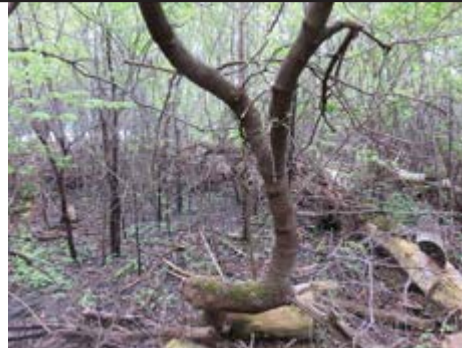
Photo 2: Understory dominated by buckthorn and box elder. Sunlight at soil is insufficient for graminoid and herbaceous regeneration.

The central portion of 29I and 29E have been opened due to construction of a board walk through the seep (Photo 1). The dappled sunlight is sufficient for continuous vegetation cover, primarily by rice cutgrass, prairie sedge, lake sedge, beggar's ticks, and reed canary grass (Photo 3). Additionally, later successional species, such as Michigan Lily, are apparent in this area. Where trees weren't cut, there is dense shade and little ground layer vegetation. (Photo 2).

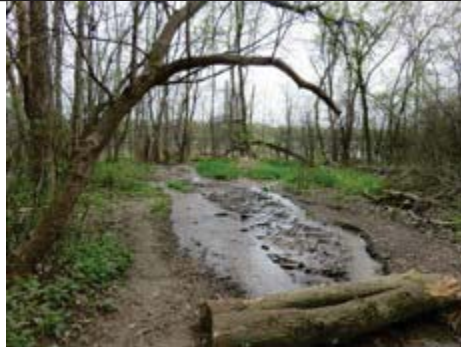
Stream too spread out

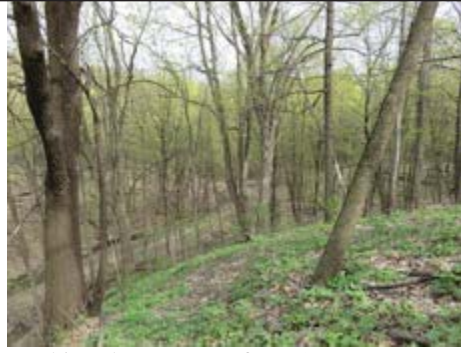
Looking downstream from 29H

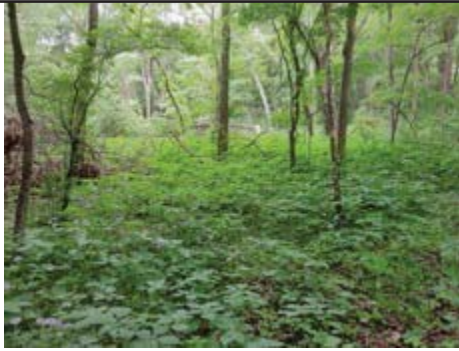
The vegetation in 39C is almost entirely dominated by wood nettle and garlic mustard.

The 2006 survey indicates a much higher diversity for the wetland area, and many of the species are absent in 2017. Potential causes of this include dense stands of buckthorn that are now taller and creating more shade, the emergence of garlic mustard, and increased shade from all species of trees. The community is dominated by silver maple, black ash, and small red elm, hackberry, and green ash. The ground layer is dominated by wood nettles and garlic mustard. Impatiens and clear weed are ubiquitous throughout. Quality vegetation occurs in the southwest section of 39H adjacent to the lakeshore because it escapes the high levels of nutrients and weedy species associated with the seep stream.

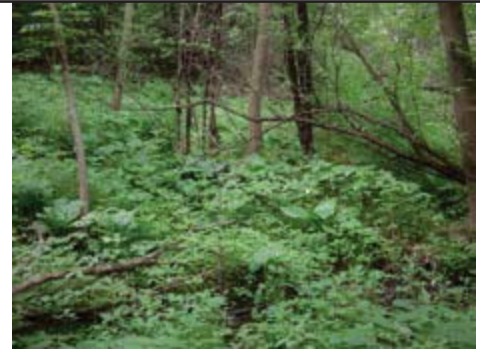
Higher quality vegetation in the SW corner of 39H include Skunk cabbage, beggar's ticks and smartweed.

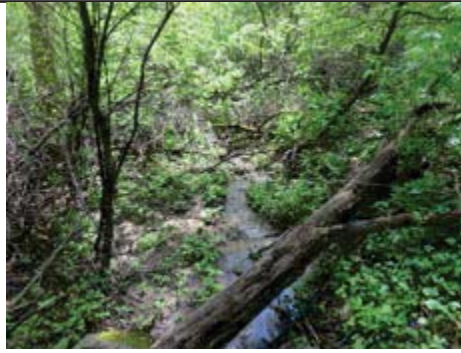
Spring stream

Along the spring stream, black ash are present, but the willows are replaced by dense stands of buckthorn interspersed with red elm, hackberry, and green ash. Several ash show symptoms of emerald ash borer. Stream bank erosion is apparent due to lack of graminoid vegetation. Wood nettle and garlic mustard are dominant, possibly due to lawn waste nutrient inputs. There is also excessive dead, fallen wood along the stream. This area has experienced a decline in plant diversity since 2006.

- Cut & stump treat undesired species
- Burn cut wood
- Seed & plug stream banks with grasses

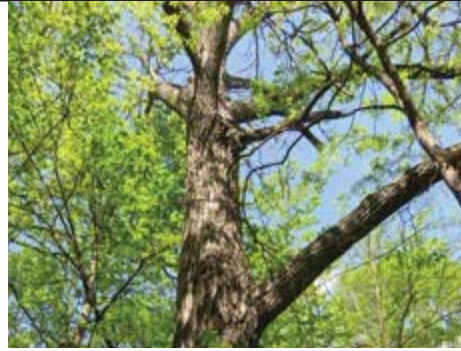
Massive butternut tree. Native Americans boiled the nuts to extract the highly nutritious oil which was used as a tackifier for pemmican. Butternut is nearly extirpated in the Minnesota River Valley,

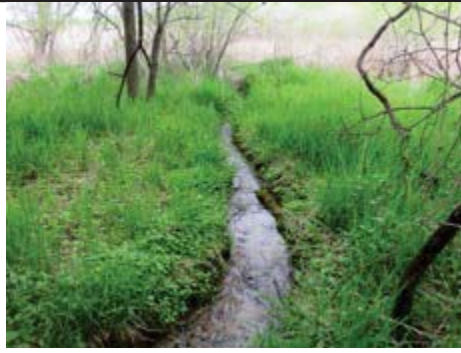
The stream in 38D shows the desired state. Graminoid vegetation forces the water into a realized channel, which is deeper, less susceptible to rapid temperature change, and has less bank sloughing and erosion.

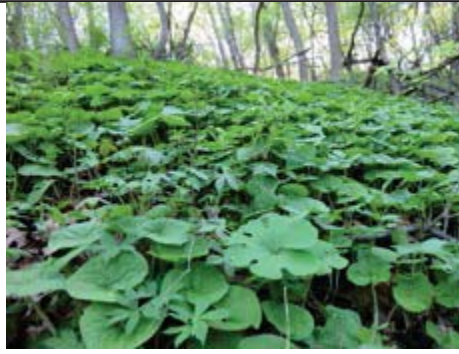
Photo 66: The east aspect of the stream shows nearly continuous ground cover.

The east facing slope along the ravine has good ground vegetation cover. This is one of the healthiest landscapes in the Minnesota River Valley. However, the west facing aspect is bare of ground vegetation. On the terrace above the stream fork, there is one of few large white oak trees (32" dbh) found in the valley. It sits in the center of a Native American encampment site.

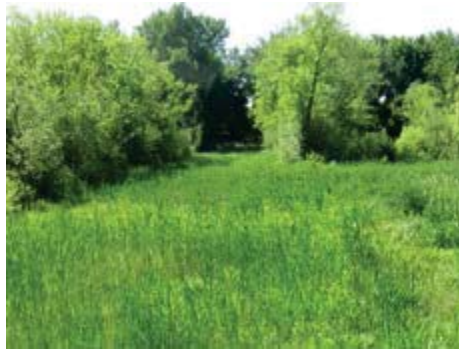
Mowed utility right-of-way

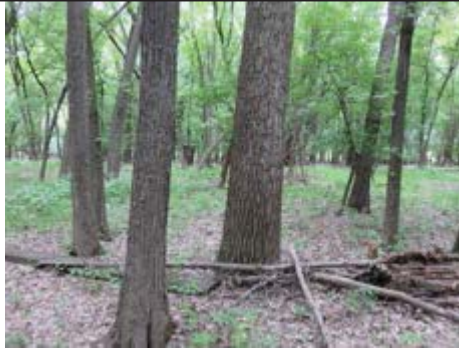
The second age class is represented by straight trunk trees of 25" dbh.

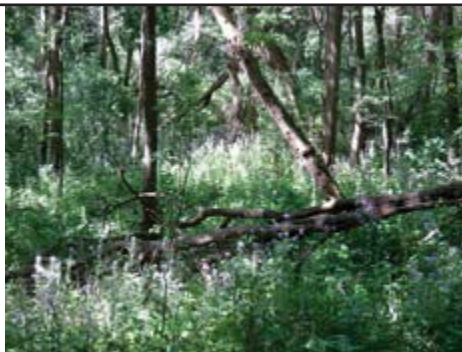
Photo 86: High nutrient soils in the lower elevations promote weedier growth.

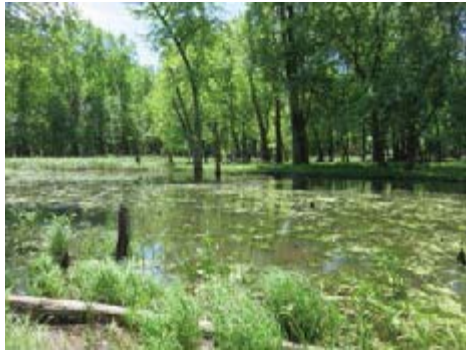
Open floodplain habitat

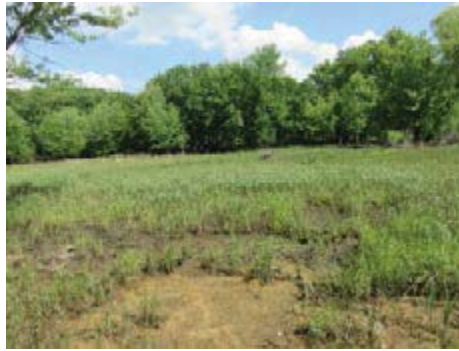
Marsh area experiences frequent flooding

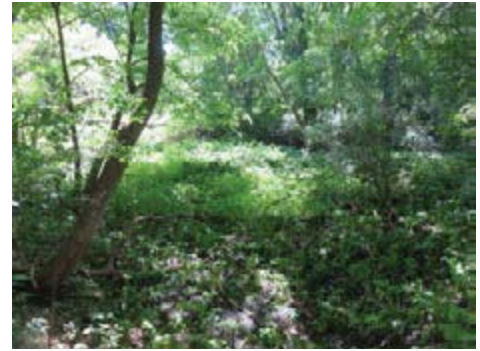
Perched seep surrounded by encroaching box elder, ash, elm and buckthorn

- Thin trees
- Remove or burn cut woody vegetation

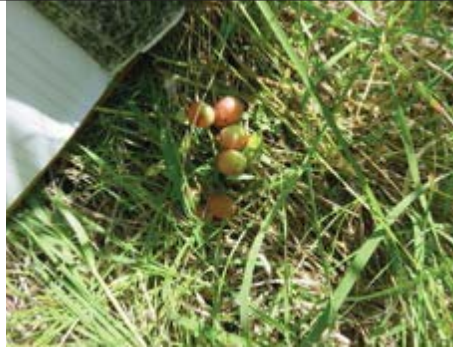
Prairie ground plum, a Native American food and a unique grassland plant this far east. This species was not recorded in the 2007 survey

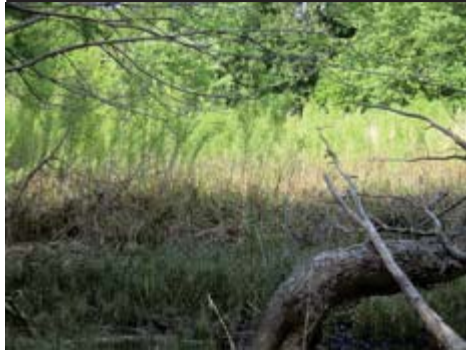
Willow encroachment near the wetlands

- Cut old stems of willows and allow resprouts to grow

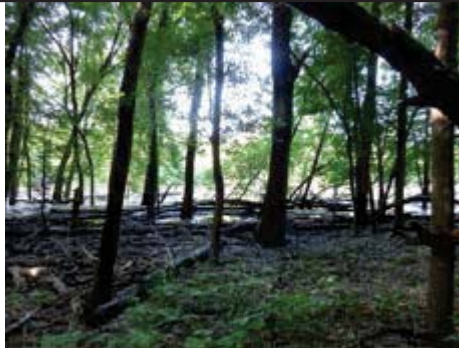
Floodplain forest system dynamics dominated by silver maple.

- Thin young trees (by machine)
- Mow
- Hay
- Prescribed burns
- Grazing

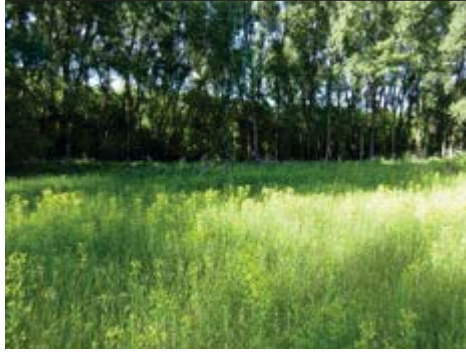
Several grassy openings are dominated with slender wheat grass and leafy spurge, which is a noxious weed. Unlike the afforested woods, the grasslands offer edible vegetation for wildlife.

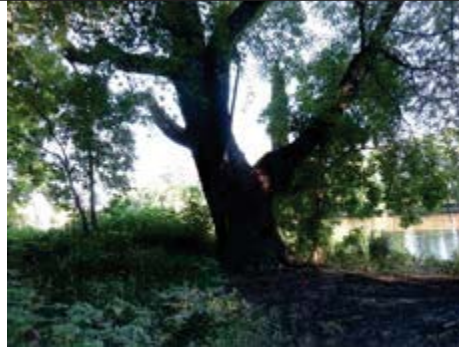
An open growth silver maple (80" dbh) suggests this area contained less tree cover historically.

Boxelder and cottonwood trees currently control ecosystem dynamics. There are a few open sites that are breezier, drier, and less buggy. They are dominated by slender wheat grass and include some leafy spurge. However, most of the floodplain is overgrown and weedy. As tree density increases, ground vegetation becomes dominated by wood nettles, wind speeds decrease, humidity rises, and biting insects are frequent. One large, open growth silver maple occurs in the southwest corner of this area.

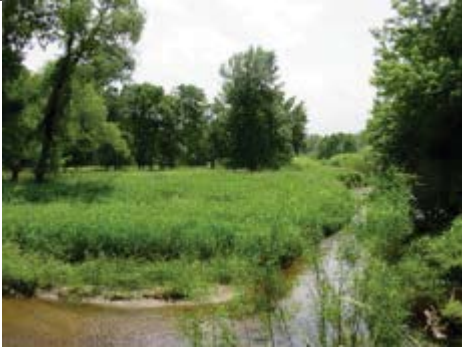
Nine Mile Creek vegetation is dominated by reed canary grass, a nitrophile.

The wetlands and marshlands are mostly dominated by native plants, but the diversity is low compared to the Colman Lake area. For instance, plants such as mint and tufted loosestrife are nearly absent in the Nine Mile Creek area, but they are common in the Colman Lake area. Surface runoff and associated nutrients negatively impact plant biodiversity in the Nine Mile Creek area. For instance, reed canary grass, an invasive nitrophile, is dominant.

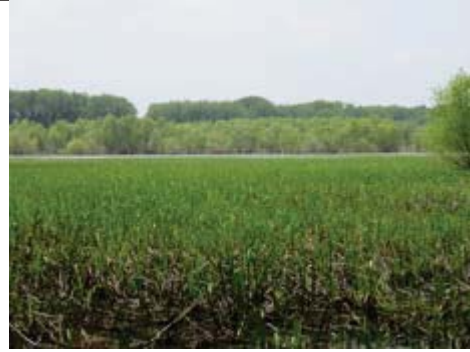
The wetland and marshland areas are primarily dominated by native plants

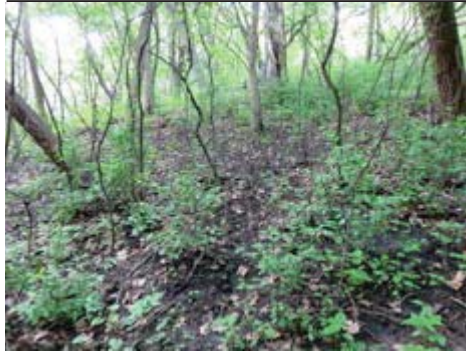
Bare soils associated with an afforested tract in the southern tip of 46M.

- Thin undesired woody species (by machine)
- Mow firebreaks and prune lower branches of cedar trees in preparation for prescribed burn
- Prescribed burn

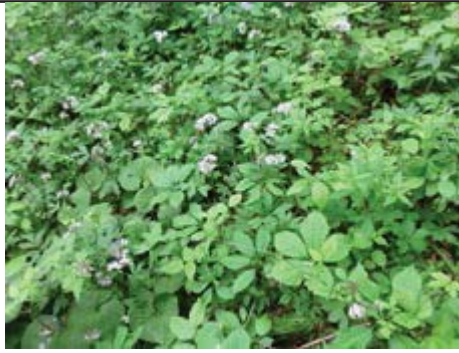
46O shows good ground layer vegetation due to being repeatedly cleared of buckthorn by a neighbor.
